MERMAID BLACKSMITH SHOP AND STABLE (7NC-D-106B)

RESULTS OF FIELD INVESTIGATIONS

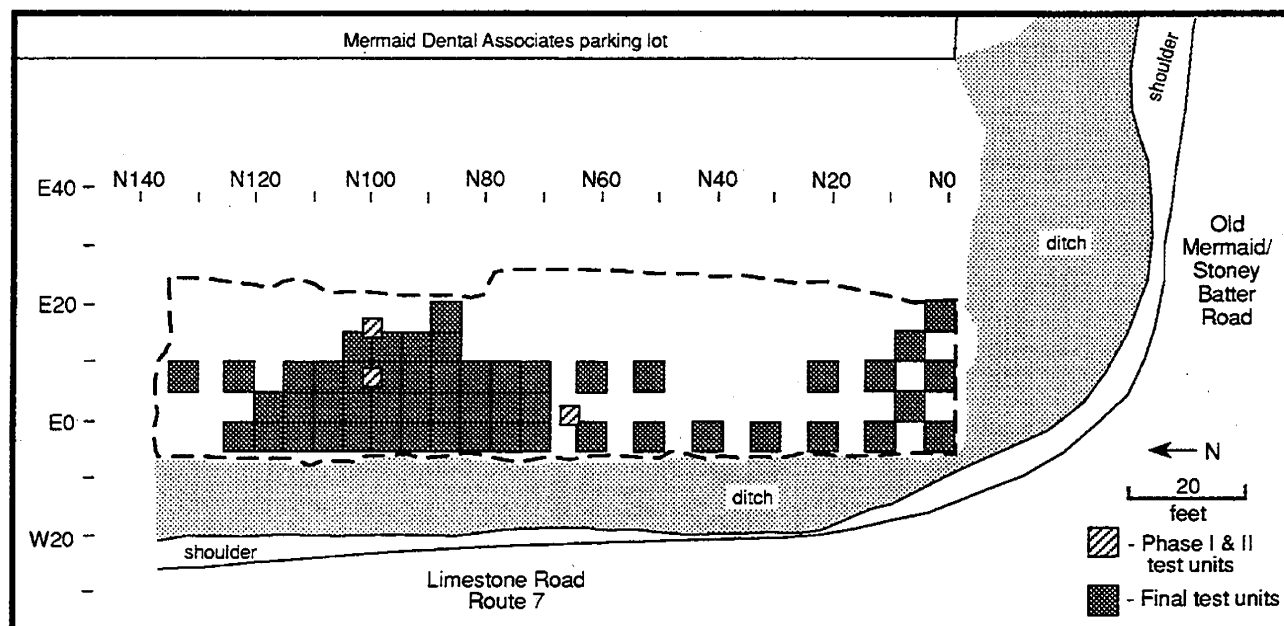
FIGURE 17

Plan of the Test Unit Excavations at Mermaid Blacksmith Shop and Stable Site

was established at the southwest corner of the stripped area. From this datum, a 5' x 5' grid was placed over the site. The 5' x 5' grid units were used as the test unit blocks excavated throughout the course of the field excavation. Provenience for each test unit was located at the southwest corner of each unit. The buried plow zone was excavated as one level. Excavated soils were screened through 1/4-inch dry screen and all artifacts recovered were bagged with the proper provenience information indicated on each bag. Plow zone excavation began in the southwest portion of the site, but soon testing began to focus on the northern half of the stripped area where plow zone soils were notably darker and appeared as a large black stain. Test units were excavated in a contiguous fashion within the buried Ap horizon (black plow zone) soils due to high artifact counts and the presence of features. A total of 52 5' x 5' test units were excavated at the site. Soil samples were collected from the buried plow zone level of 38 of these units (Figure 17). It was originally believed that the blacksmith shop was located close to the intersection. This assumption was changed during the course of the investigations when it was discovered that the remains of the rear wall of the shop and stable buildings were still extant beneath the buried plow zone soils, and extended parallel to Limestone Road for nearly 120 feet.

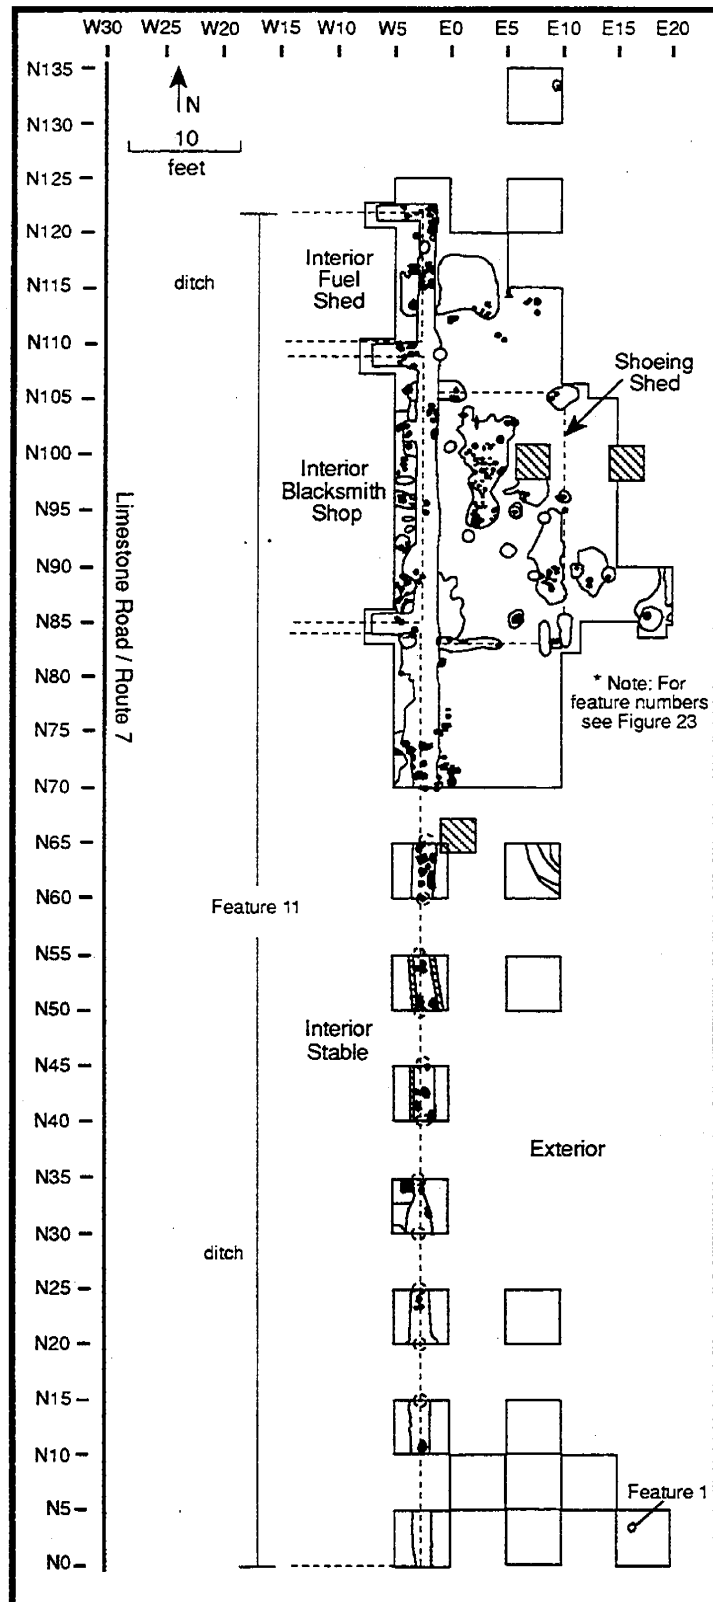
FIGURE 18

Plan of Test Units and Features at Mermaid Blacksmith Shop and Stable Site

The investigations at the Mermaid Blacksmith Shop located a total of 46 features (Figure 18). The features at the site can be divided into several groupings: those associated with the stable, those located inside of the shop, those located in the northern addition, the features located outside of the shop and possibly in a shoeing shed, and those in the rear yard area. Each of these groups will be discussed separately below.

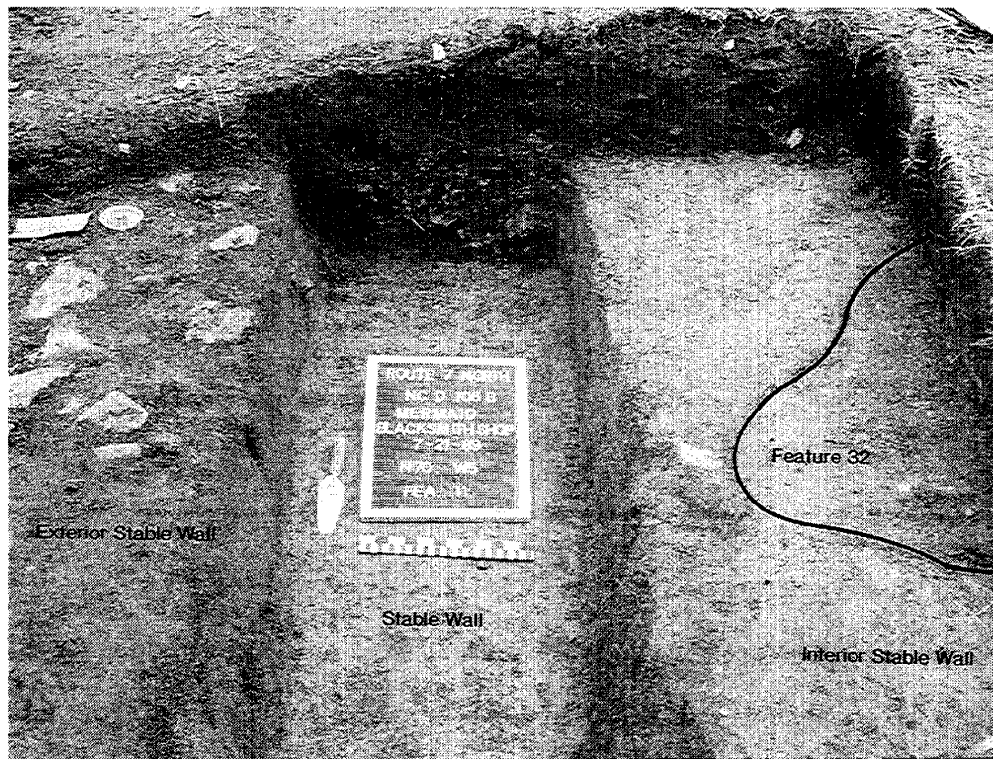
PLATE 4
Feature 11, N70W5, After Excavation

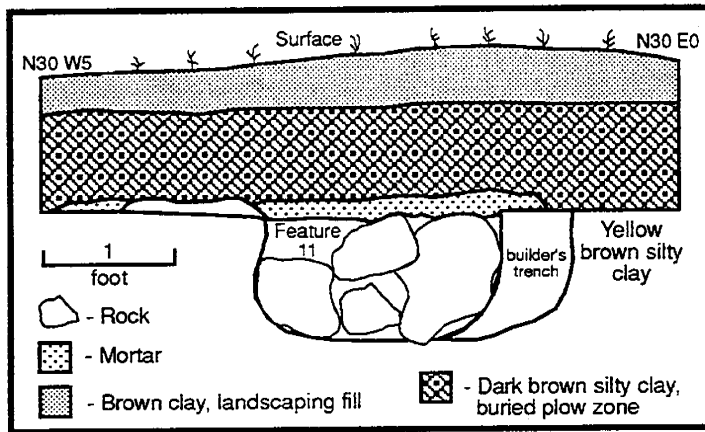
FIGURE 19

Profile of North Wall of N30W5

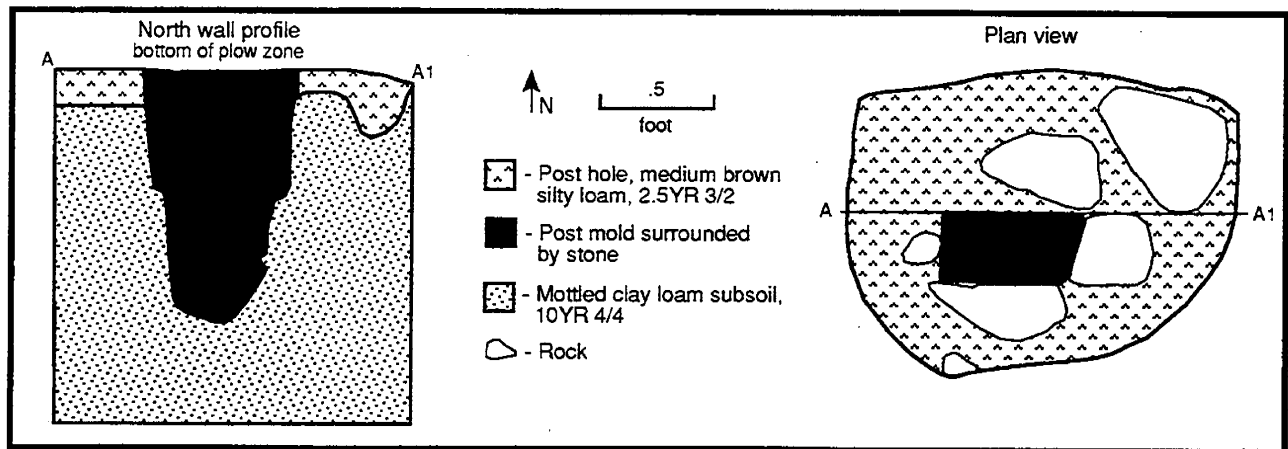
FIGURE 20
Plan View and Profile of Feature 25

Features 25, 27 and 32 were located on the interior side (or west side) of Feature 11. Feature 25 (Figure 20) was a roughly rectangular (1.5' x 1.2') post hole with a rectangular post mold (.3' x .6') located in the center of the hole. The post was 1.1' deep and was supported by large stones and rocks. Neither hole nor mold contained artifacts. Feature 27 was an 8.7' long, shallow soil stain located in the northeastern corner of the stable (N70W5 and N75W5). Feature 32 was located in N70W5 and was similar in depth to Feature 27. These two features contained small amounts of glass, brick, redware, nails, and bone. Feature 32 contained a jasper flake.

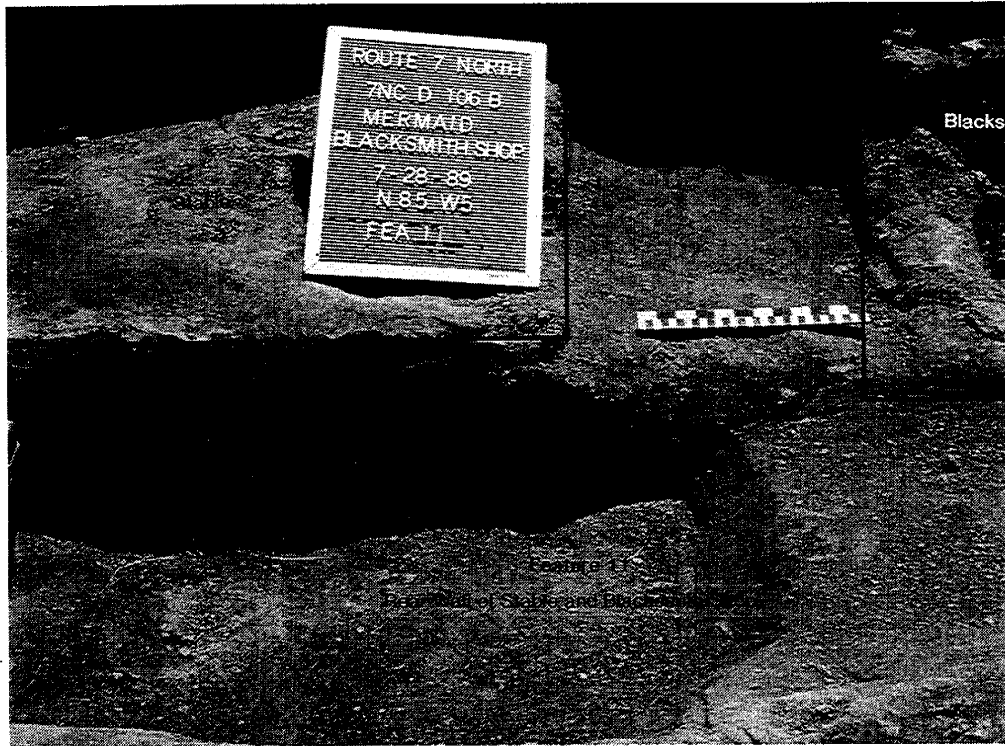
PLATE 5

View Looking West at the Joining of the Blacksmith Shop and Stable, N85W5

At N85W5 the stable wall portion of Feature 11 butted directly into the blacksmith shop portion of Feature 11 (Plate 5). The blacksmith shop section of Feature 11 was only .5' deep, compared to the 1.0' deep stable section to the south, indicating a separate period of construction. The robbed mortared stone wall of the shop was approximately 2' wide. The entire rear wall, 26' long, was uncovered, and small parts of the south and north walls were found where they had not been disturbed and destroyed by the widening and ditching of Limestone Road (Plate 6). Table 7 contains a summary of the features

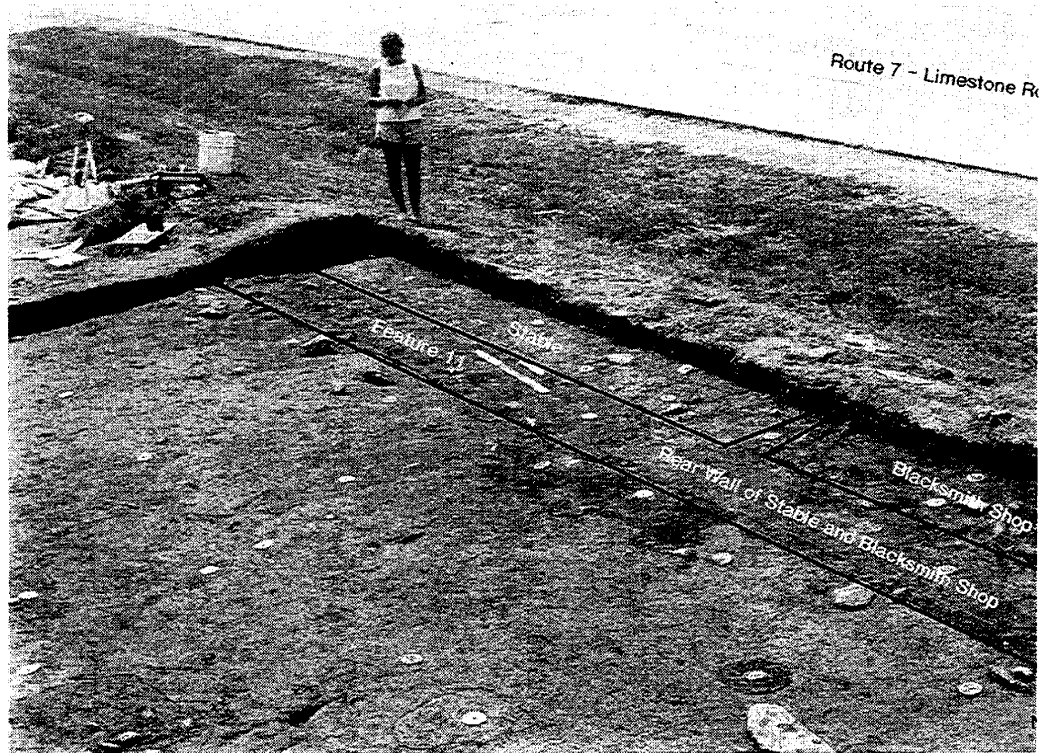
PLATE 6

Feature 11, Rear Wall of Blacksmith Shop, Prior to Excavation

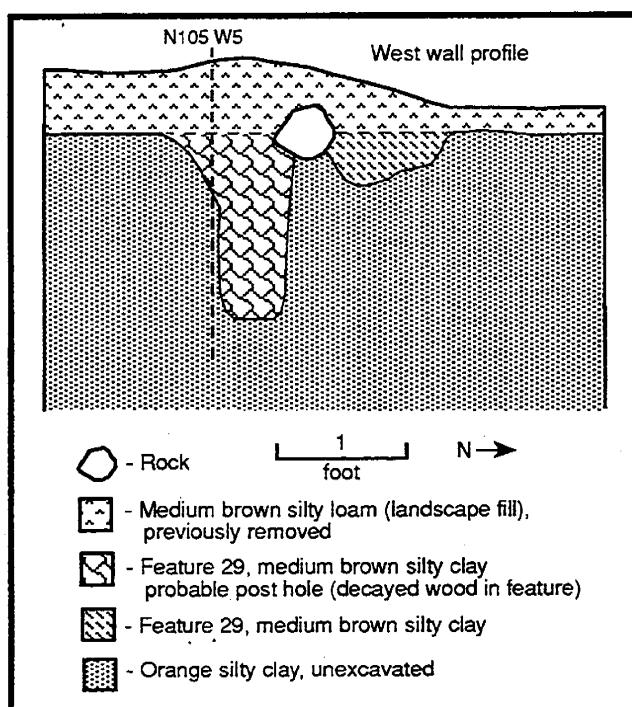
FIGURE 22
Profile of Feature 29

Feature 29 was located close to the extreme northeast corner of the shop. At the surface of the subsoil the feature seemed to measure 2.1' across. It was found however, that the actual post mold was

approximately .5' square, and extended to a depth of 1.5' (Figure 22). The soils were a medium brown silty clay, and the feature contained nails, slag, redware, and brick fragments.

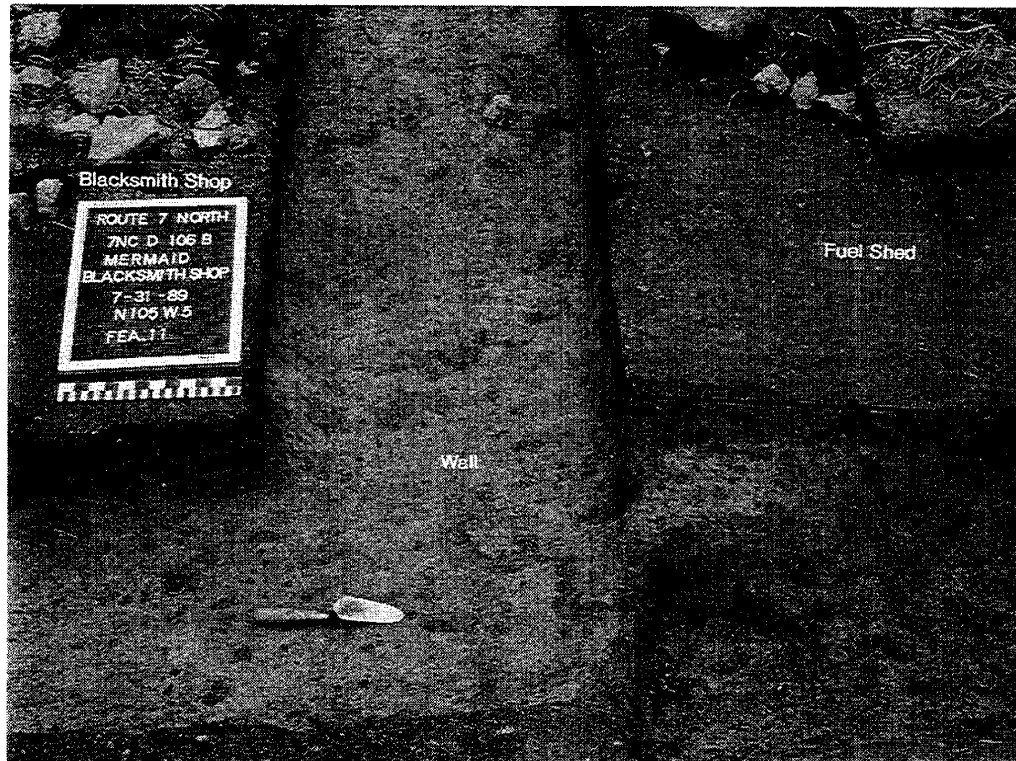
PLATE 7

Feature 11, N105W5, Corner of Blacksmith Shop and Fuel Shed, After Excavation

An addition was uncovered butting against the north wall of the blacksmith shop, beginning at N110W5 and extending to N122W5 (Plate 7). Measuring approximately 12' to the northeast corner of Feature 11, the wall made a right-angle turn towards Limestone Road, and was truncated by the road and ditch (Plate 8). Based on the large amount of coal recovered from this area during the plow zone testing, this addition is interpreted to have been a coal bunker or shed attached to the blacksmith shop. The depth of Feature 11 along this addition (approximately 1.0' deep) was very similar to the depth of the stable wall that adjoined the south wall of the shop, suggesting that these two buildings were constructed at about the same time, and perhaps by the same stone masons (Plate 9). The stones used in the construction of the addition were more angular than those found in the shop section, and the northeast corner of the addition showed evidence of reinforcing with cobbles. Table 8 summarizes the features associated with the fuel shed.

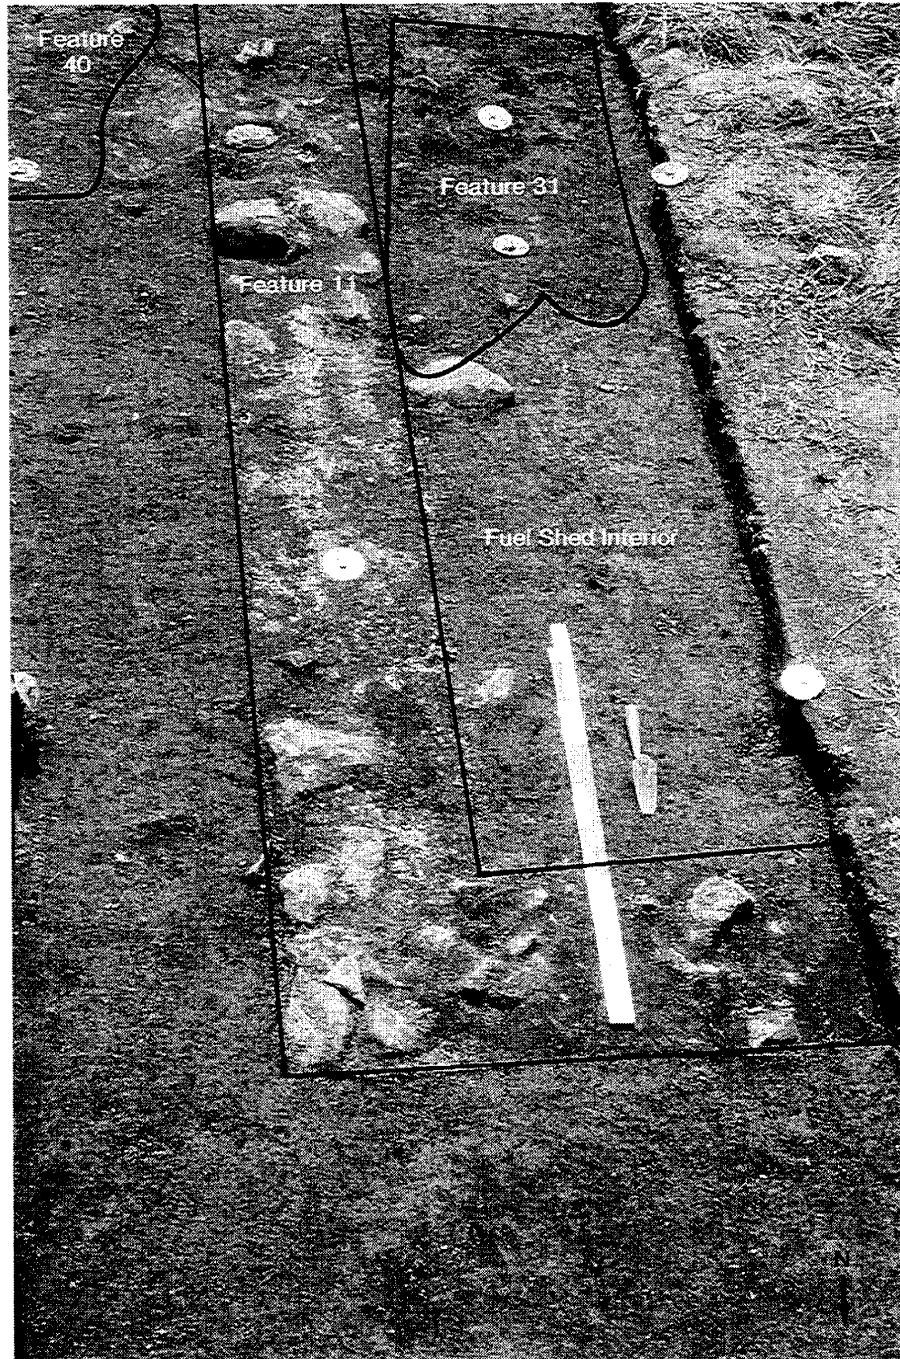
PLATE 8

Feature 11, Northeast Corner of Fuel Shed,
Prior to Excavation

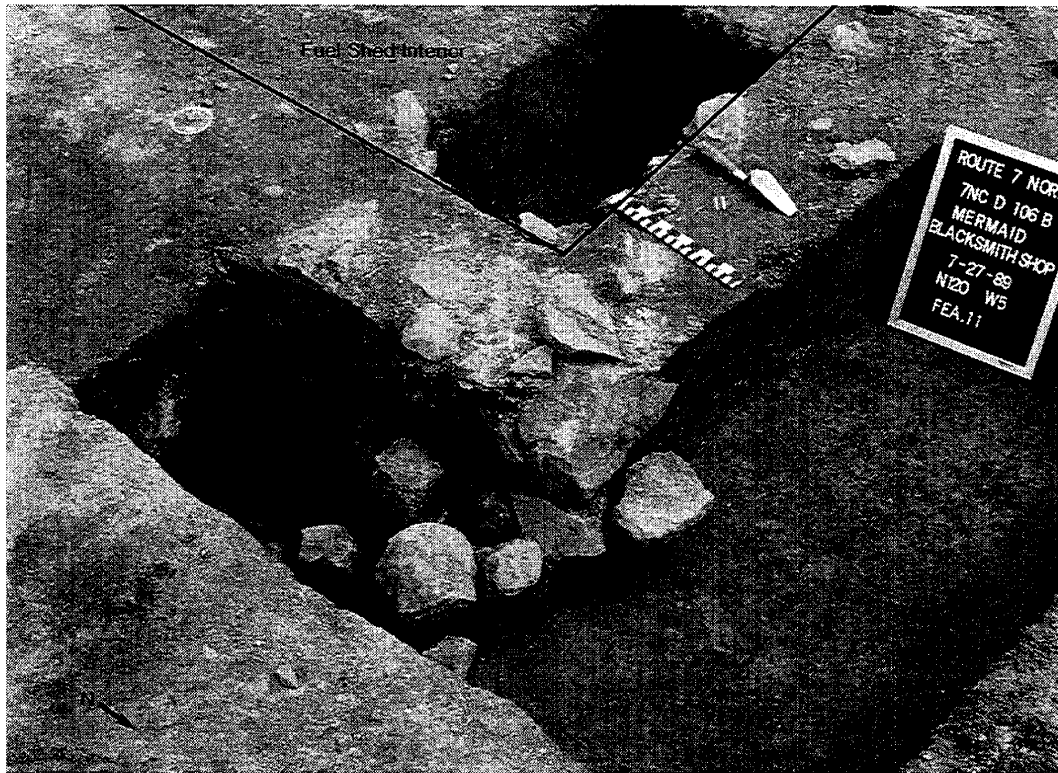
PLATE 9

Feature 11, Northeast Corner of Fuel Shed, After Excavation

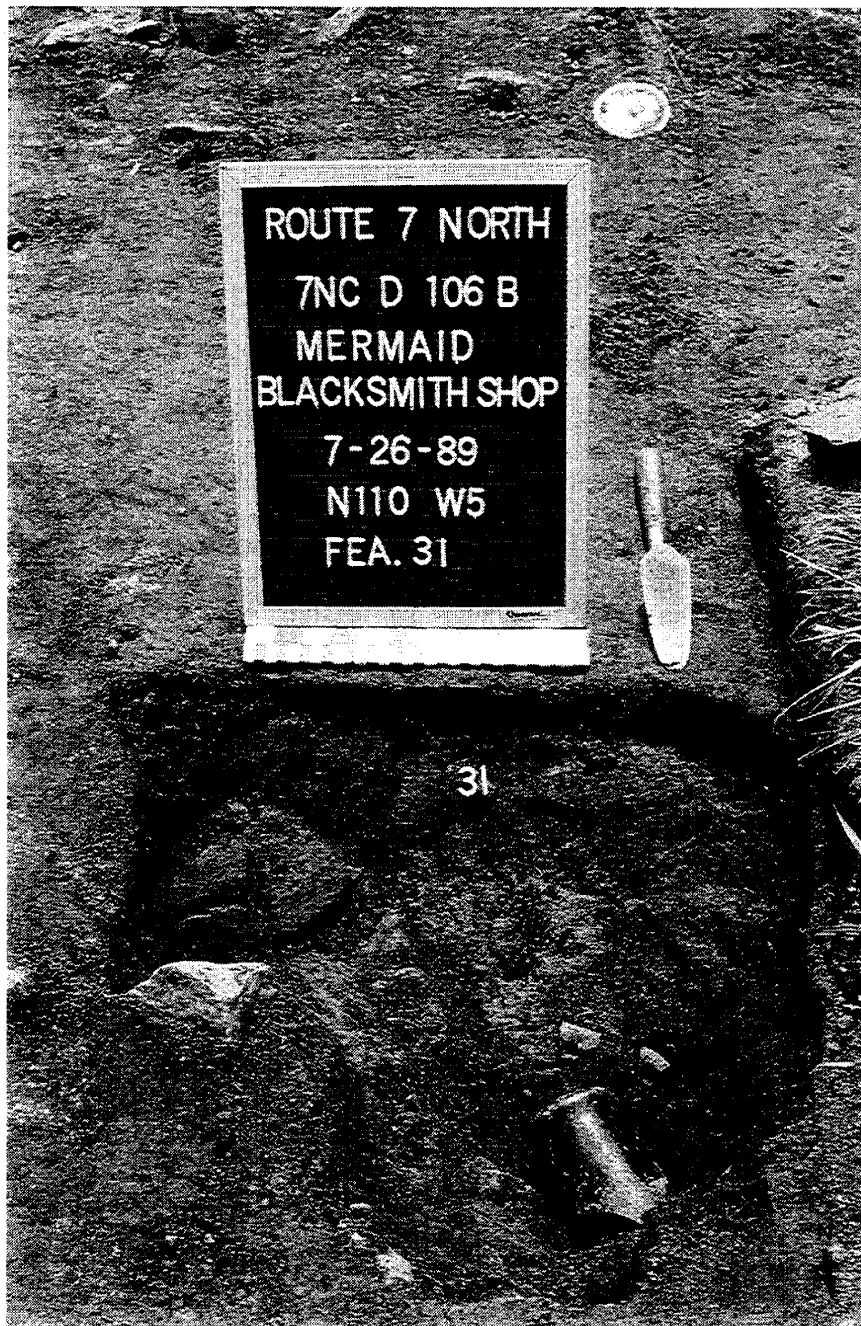
PLATE 10

Bottle Base (1790-1825) Recovered from Feature 31
(D34 No. 30)

amount of coal and charcoal, and a complete glass bottle base dating from the period 1790-1825 (Plate 10). Parts of this bottle were also recovered from Feature 4.

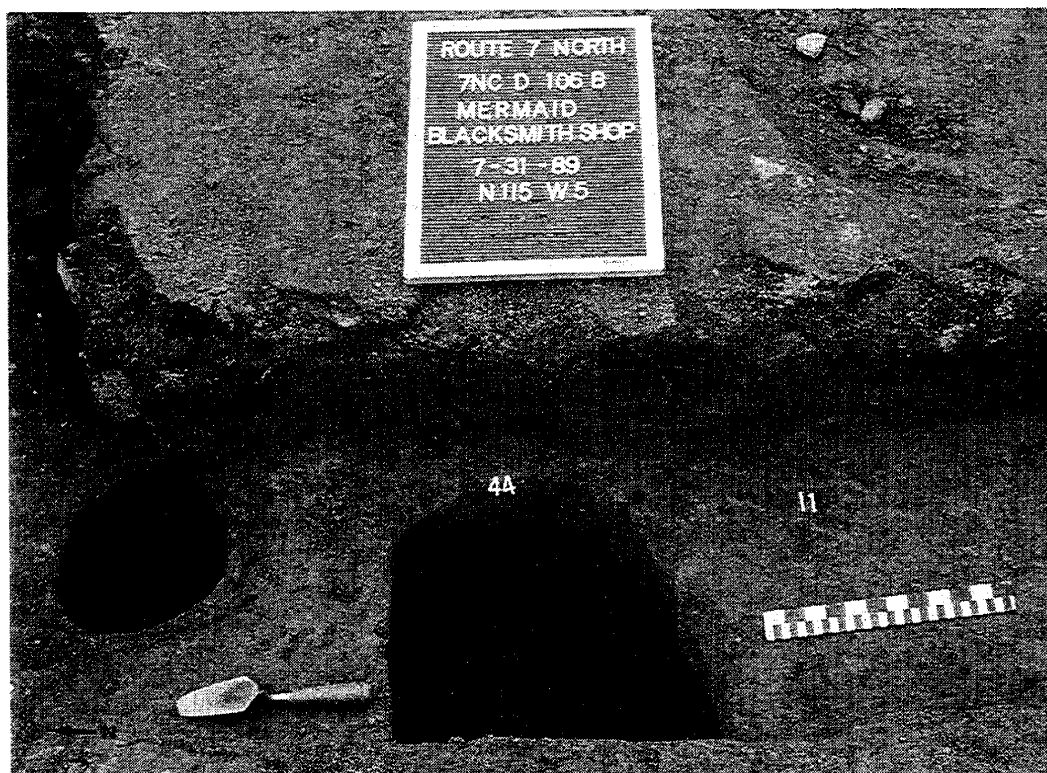
PLATE 11

Feature 44, Located inside of Feature 11, (Fuel Shed Addition), After Excavation

Two post hole features were located within the rear wall of the addition, beneath Feature 11 (Plate 11). Features 44 and 45 were found in Test Unit N115W5 and possibly predated the construction of the coal shed addition (Feature 11). Feature 44 was a square post 1.8' deep, and Feature 45 was a smaller round post of approximately the same depth. Feature 30, located in the shop portion of Feature 11 in N105W110, was a post that was also bisected by Feature 11, suggesting that it too, like Features 44 and 45, may have predated the construction of the stone foundation.

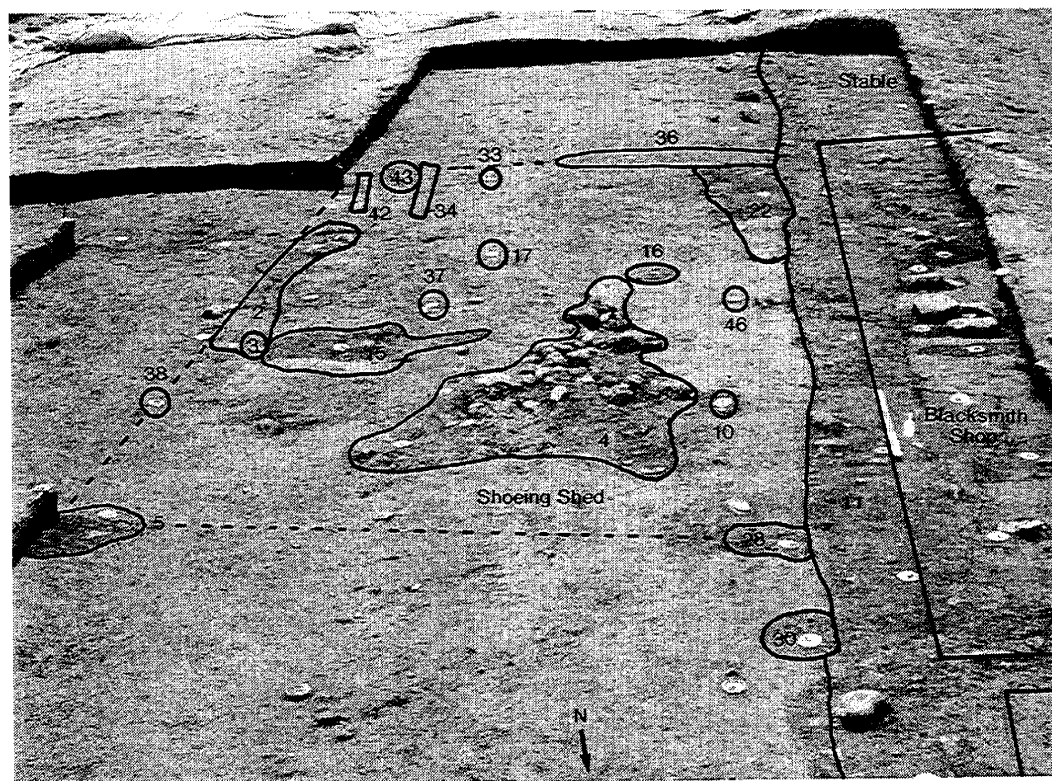
PLATE 12

Horseshoeing Shed Features, Prior to Excavation, Looking South

The best archaeological evidence at the Mermaid Blacksmith Shop and Stable site was associated with a structure that is tentatively interpreted as a horseshoeing shed (Plate 12). A total of

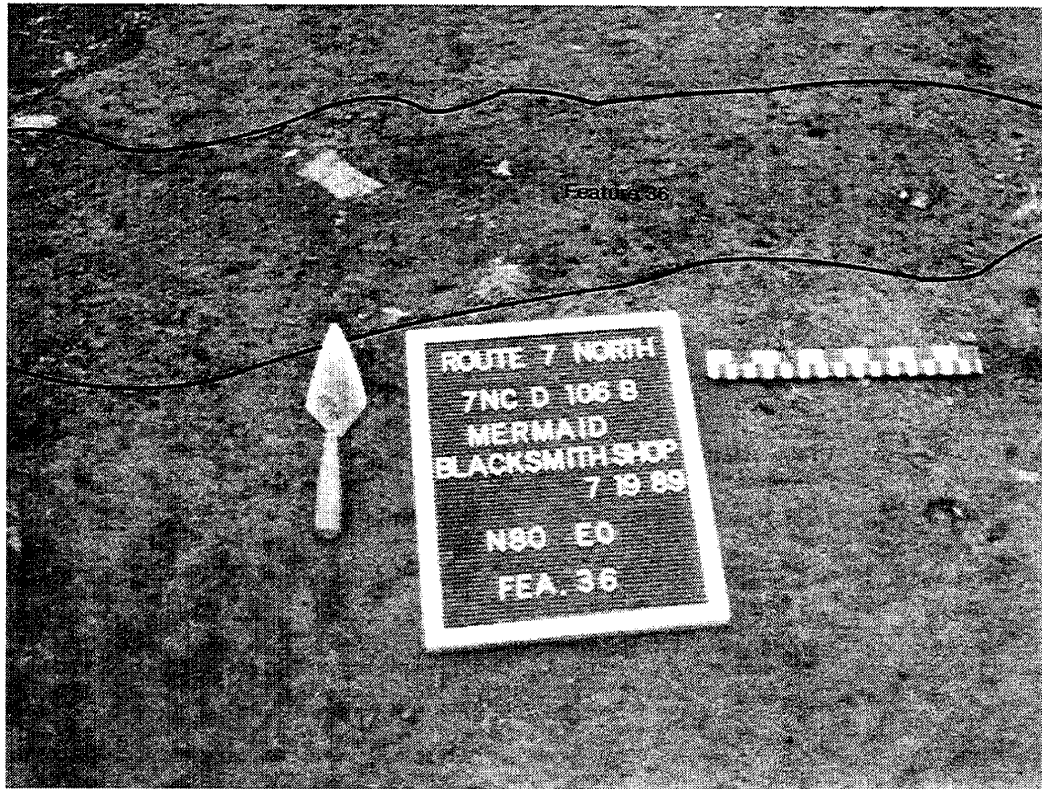
PLATE 13
Feature 36, Prior to Excavation, Looking North

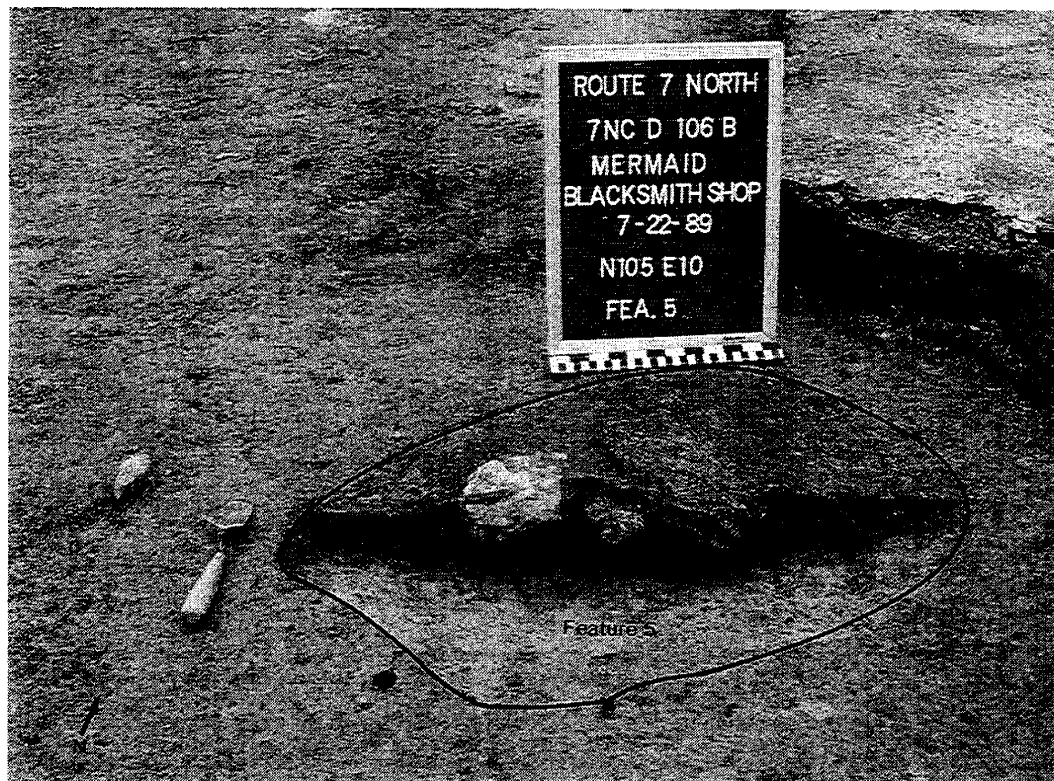
PLATE 14
Feature 5, Cross-Section

The exterior walls of the shed are represented by Features 36, 34, 43, and 42 along the south wall; by Features 2B and 38 along the east wall; Feature 5 at the northeast corner; and Feature 28 at the northwest corner. Together these features form a shed approximately 22' (north-south) by 12' (east west), butting directly against the east (rear) wall of the blacksmith shop. The corner features associated with the shed are all very shallow depressions. Features 36 and 28, located closest to the rear wall of the shop, appear to be the remains of shallow ground-laid wooden sills (Plate 13). Feature 5 at the northeast corner of the shop was also very shallow (.4' deep), and was a circle roughly 2.0' in diameter (Plate 14). Like the ground-laid sills, Feature 5 may represent the remains of a wooden block or pier

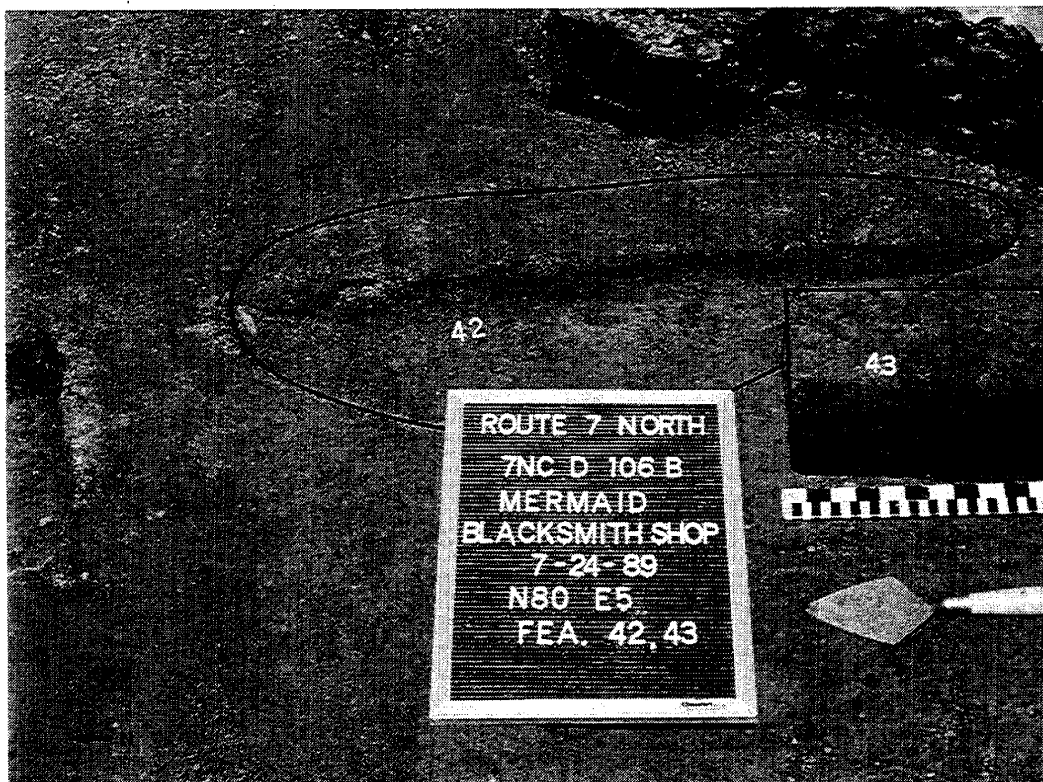
PLATE 15

Features 42 and 43, Cross-Section

support for the shoeing shed. The three southeast corner features (34, 43, and 42) represent both ground-laid sill and post construction (Plate 15). Features 42 and 34 are the remains of sill supports, while Feature 43 was a true post hole and mold, 1.0' square, extending about .8' deep and containing nails and brick fragments.

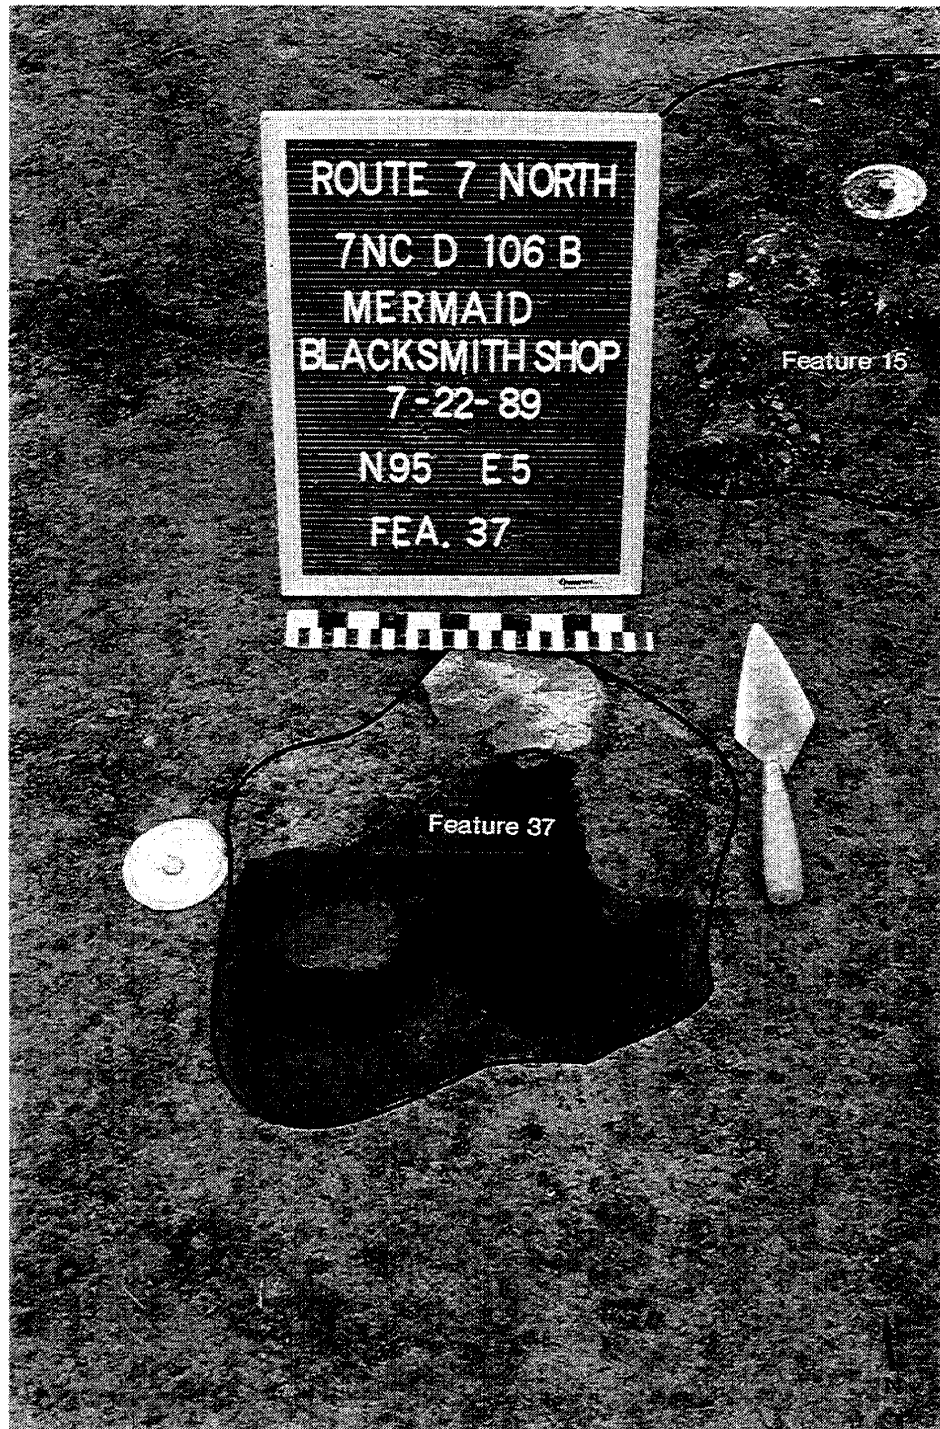
PLATE 16

Feature 37, After Excavation

Inside of the shed several post holes and molds were excavated (Features 2A, 3, 16, 33, and 37). All of these features were between 1.1' and 1.6' deep, and all contained support stones jammed into the post hole in direct association with the post mold (Plates 16 and 17). Feature 2B, located along the eastern edge of Feature 2, was also a post hole and mold, although it was only .8' in depth. Both Feature 2A and 2B intruded upon Feature 2.

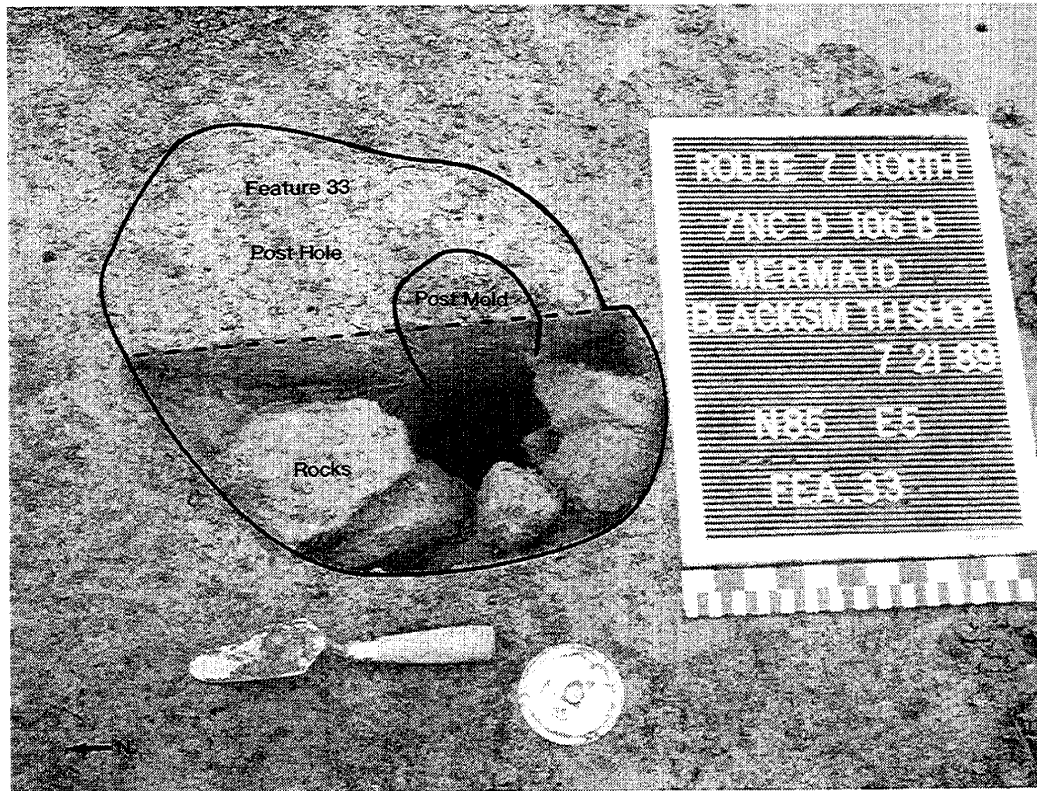
PLATE 17

Feature 33, Cross-Section

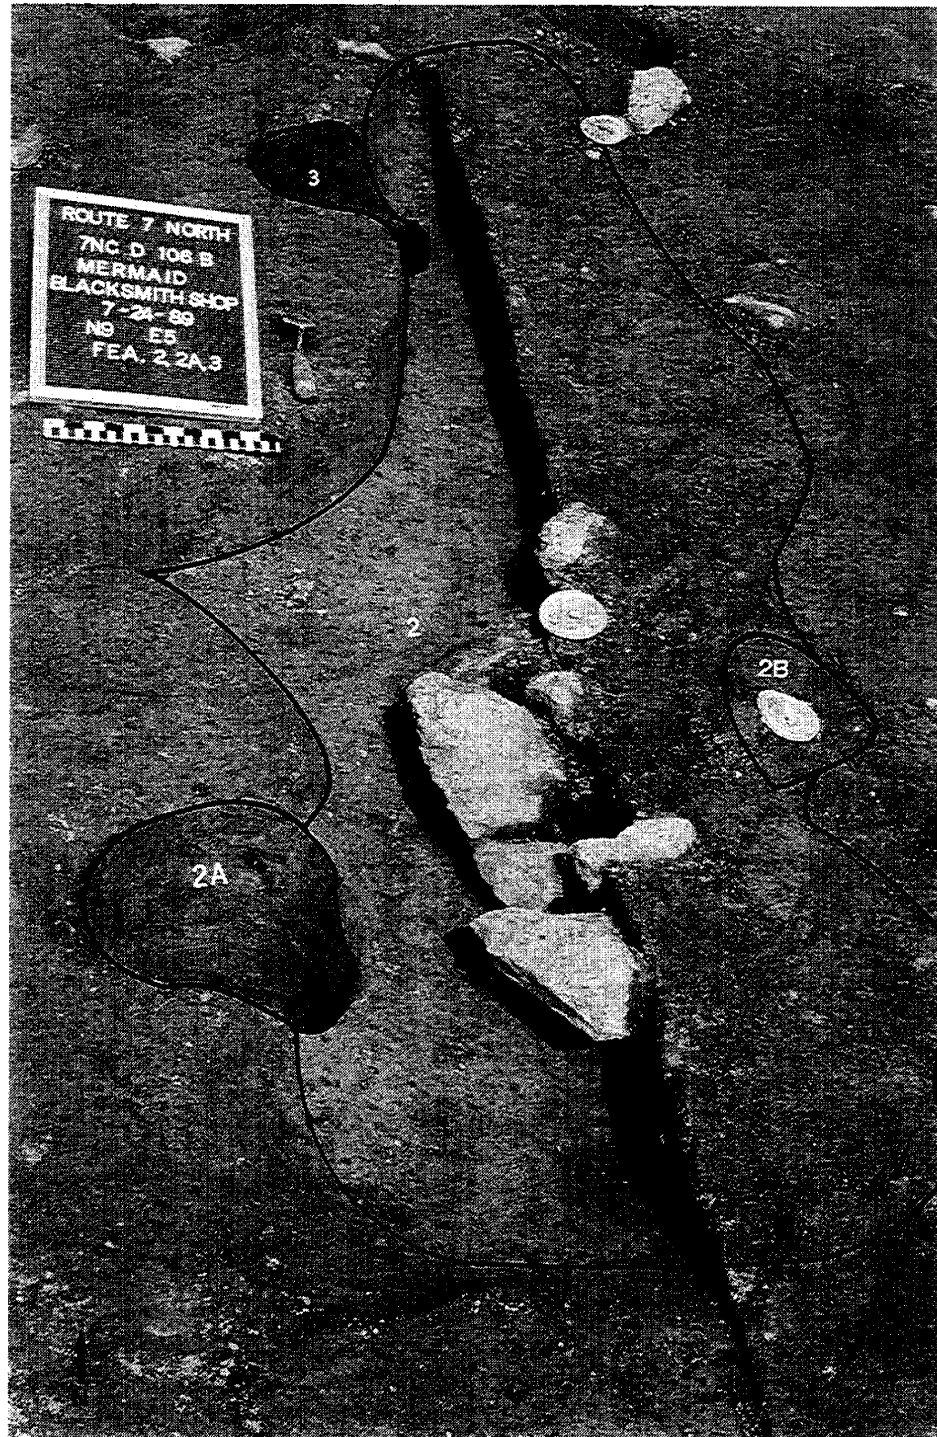
PLATE 18

Feature 2, Cross-Section, Showing Intrusion of
Features 2A and 3

Two large amorphous features (numbers 2 and 4) were located inside of the shoeing shed. Feature 2 was roughly oval in shape, measuring 9' x 3' (Plate 18). The feature contained large amounts of charcoal, over 14,000 grams of brick, 970 grams of slag, and cobbles, along with smaller numbers of metal fragments, horse shoe parts, cut and wrought nails, shoeing nails, rivets, iron sheeting, and ceramic

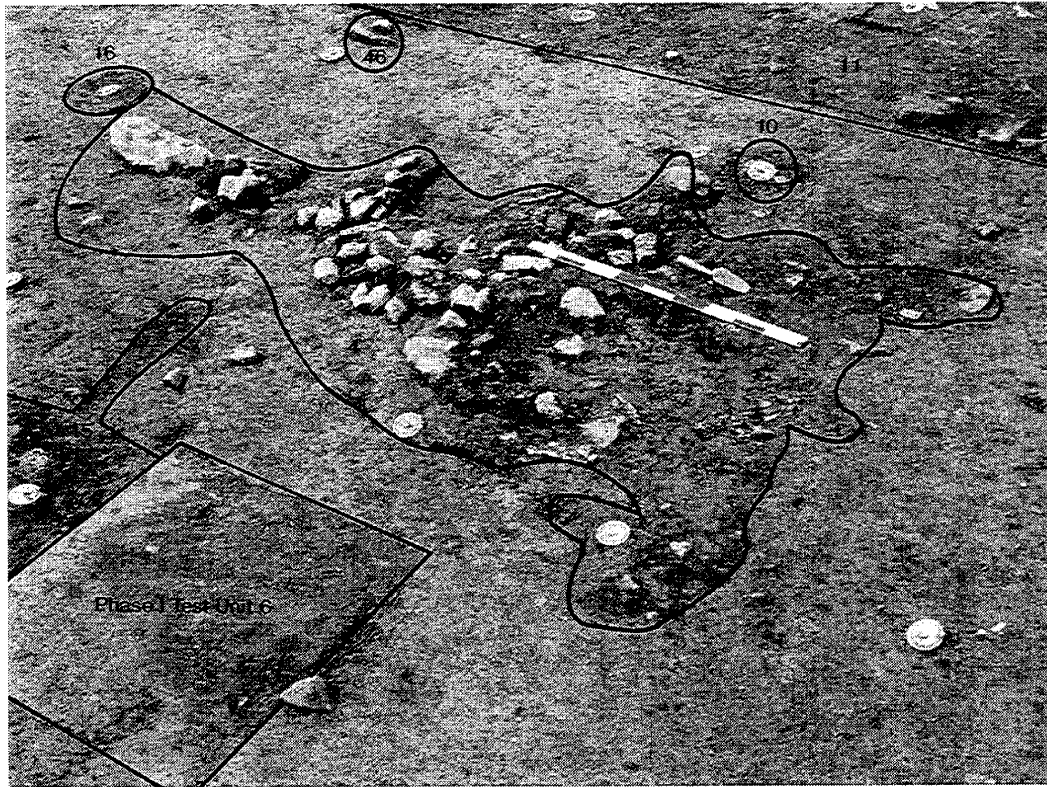
PLATE 19

Feature 4, Prior To Excavation

Feature 4 (Plate 19) was remarkably similar to Feature 2; measuring 10' x 5', it was shaped roughly like a triangle with the northern end of the feature as the base. The bottom of the feature was irregular and pocketed, averaging only .4' in depth, except in the northwestern and northeastern corners, where the feature was slightly deeper. Over 21,400 grams of iron slag, 2,160 grams of mortar, and 108 grams of brick were recovered from the feature, along

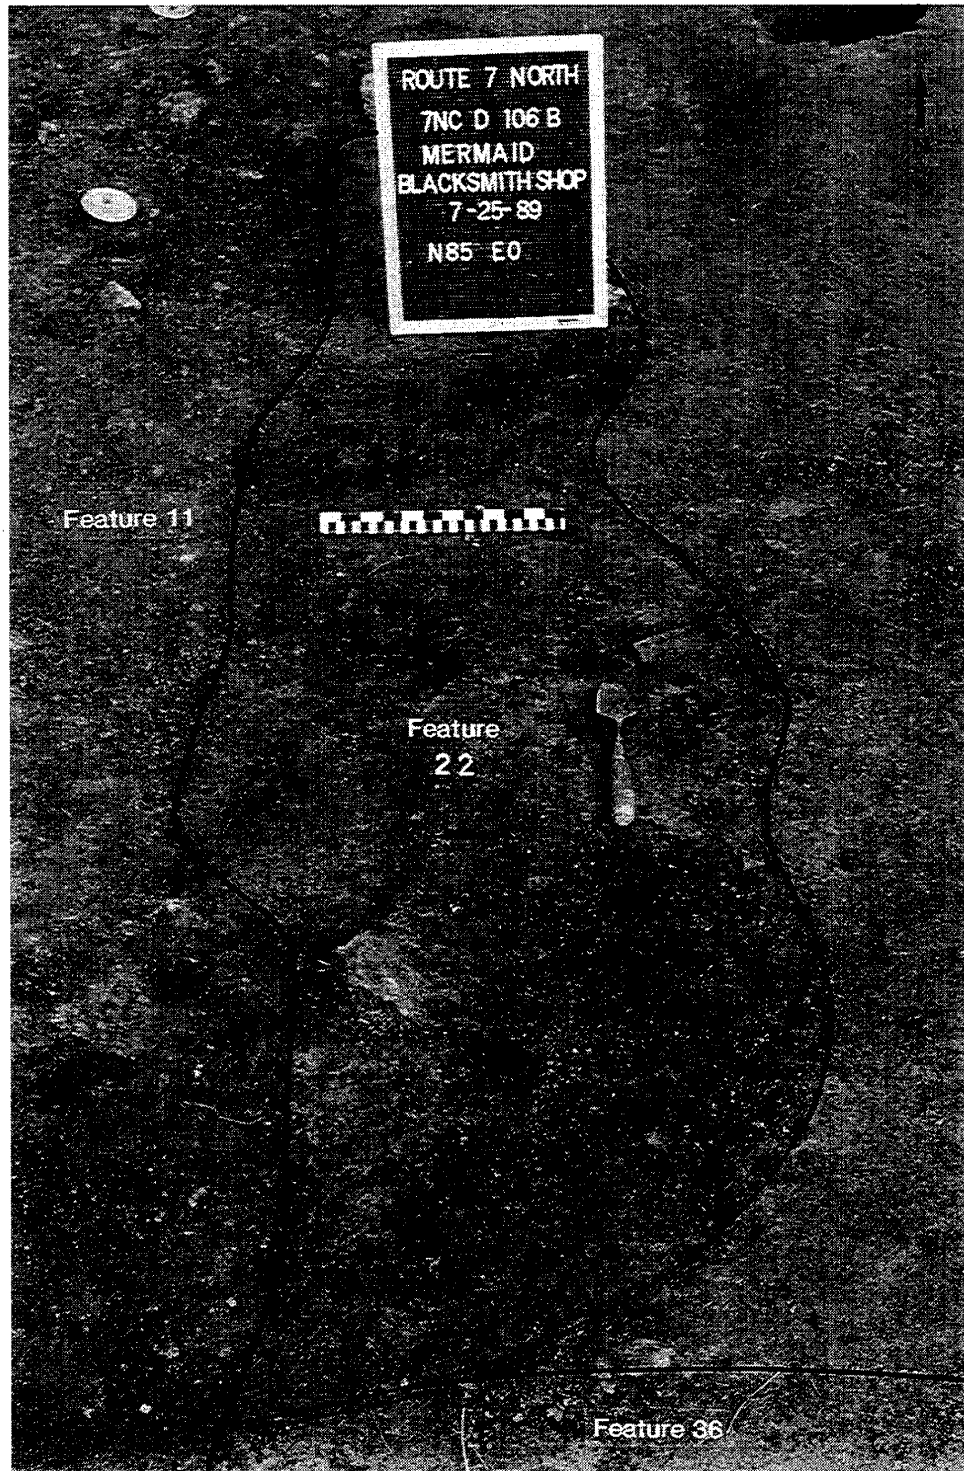
PLATE 20

Feature 22 (Trash Debris Pile),
Prior To Excavation

Feature 22, located in the extreme southwestern corner of the shoeing shed, butted up against the rear foundation wall of the shop (Feature 11) and the southern wall of the shed (Feature 36) (Plate 20). The feature was about 6.0' long and 1.5' wide, but was very shallow, measuring only .2' below subsurface. Feature 22 was an amorphous, ill-defined dark silt loam stain containing burnt wood and charcoal, as well as window and bottle glass, nails, metal parts, redware and creamware fragments, and one jasper and one quartz flake. Feature 22 is interpreted as a trash or debris pile located within the shoeing shed.
